## MARINE INVESTIGATION REPORT

M02C0011

**STRIKING**

**BY THE TUG-BARGE UNIT *PROGRESS/PITTS CARILLON***

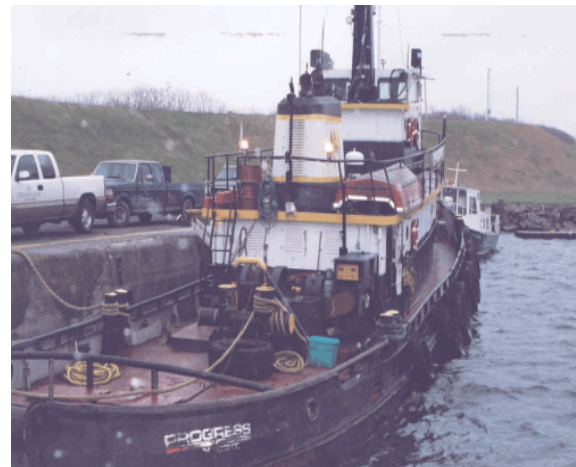
**Photo 1.** Harbour tug *Progress*

On the main deck, just aft of the superstructure, is a towing winch and a set of towing bollards for the purpose of pulling on a towline over the tug's stern (see Photo 1). The tug was not designed for push-towing operations and was not fitted with a push-towing arrangement.

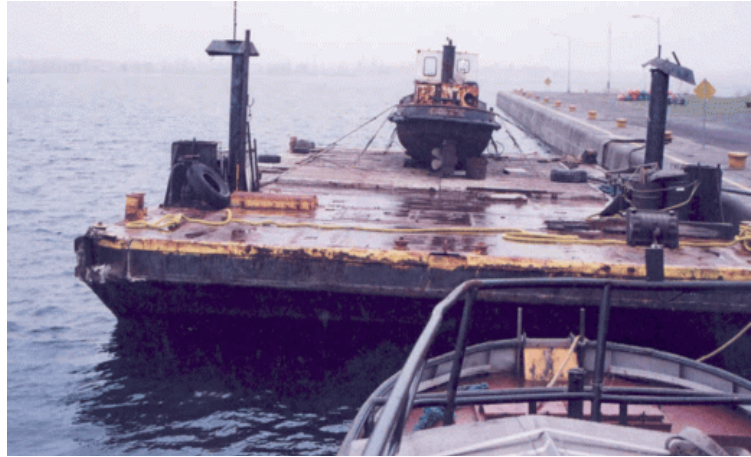
**Photo 2.** Barge *Pitts Carillon* with deck cargo (work boat) aft

The *Pitts Carillon* is a flat-topped steel barge designed to carry deck cargo. It is fitted with two anchoring spuds, which were in the raised position for transiting the Seaway. A 10 m long work boat was secured aft on the deck at centre. The spuds and work boat projected approximately 3.5 m above the barge's deck (about 5.5 m above the waterline). (See Photo 2.)

Five minutes prior to the occurrence, the lookout was sent below deck, thus depriving the watch of his services. At this juncture, the first officer was required to steer steady on course 220 (T) while planning a course alteration off crib light 82. The difficulty of the task was compounded by the fact that he was also required to use visual cues both forward and aft, i.e. the leading lights, the Doran Shoal range lights located abaft on the north shore, and crib light 82 ahead. In order to use the chart or radar to carry out course adjustments, the first officer was required to leave the helm, quickly find the information he needed and return to steer the vessel. However, his view of crib light 82 may have been intermittently obstructed by the work boat and spuds on the barge, as well as by the shore background lighting.

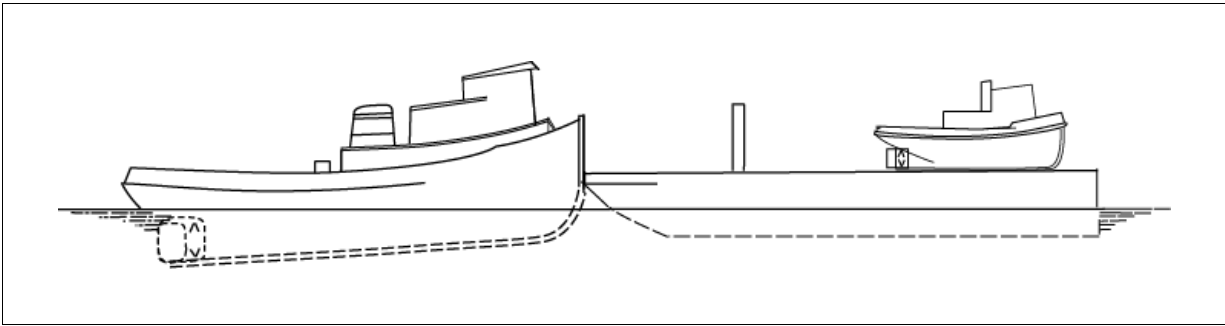
**Figure 1.** Push-towing configuration of the tug *Progress* and barge *Pitts Carillon* when leaving Montréal

At 2105,<sup>2</sup> on 20 April 2002, the tug *Progress*, pushing the barge *Pitts Carillon*, departed Montréal bound for Hamilton, Ontario. The tug's bow had been made fast to the bow (raked end) of the barge, thereby making the square-ended stern of the barge the leading edge of the tow (see Figure 1). En route, the master observed that the tug-barge unit proceeded at an unusually slow speed of only 4 knots at full ahead power.

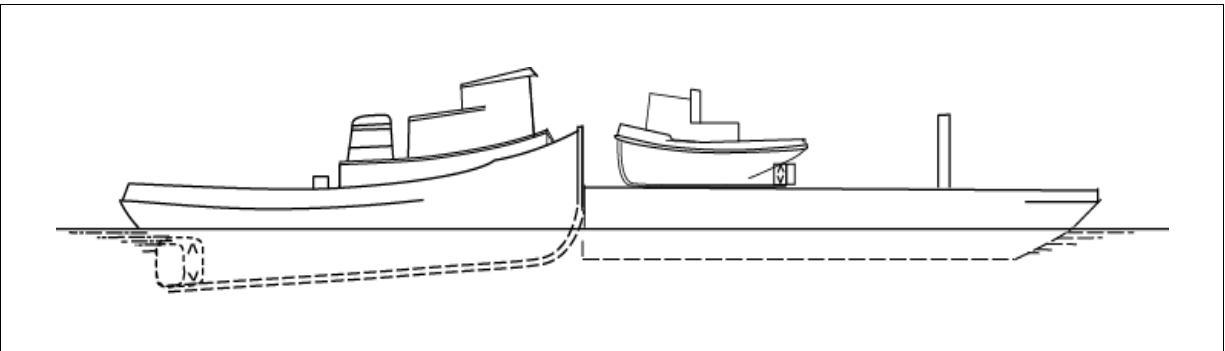
**Figure 2.** Push-towing configuration after disconnecting and repositioning vessels

At 0130 on 21 April 2002, the tug-barge unit tied-up at the Côte-Sainte-Catherine approach wall. The crew rested until about 0500, and at 0530, they undertook to disconnect the tow and reposition the tug to make its bow fast to the stern of the barge (see Figure 2). Upon completion of the tug-barge connecting rigging, concern was expressed that the rig was inadequately secured and that additional spring lines were necessary to safely operate the tow. The master did not deem it necessary to rig additional spring lines. However, when the unit stopped later, during the Seaway transit, extra spring lines were utilized.

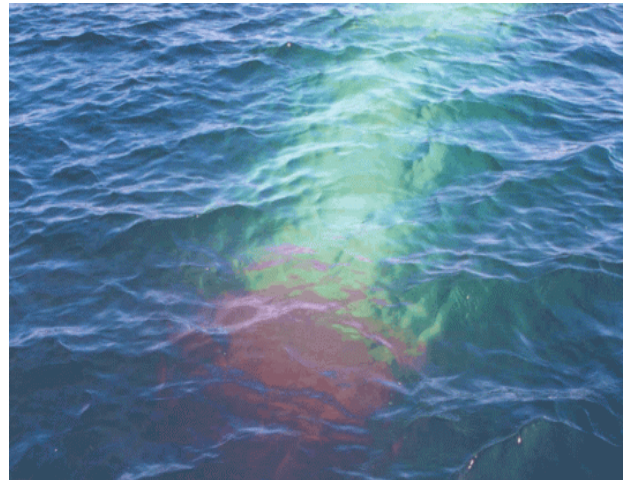
**Photo 4.** Collapsed crib light 82 under water.

Crib light 82 was knocked from its concrete base and remained submerged (see Photo 4).

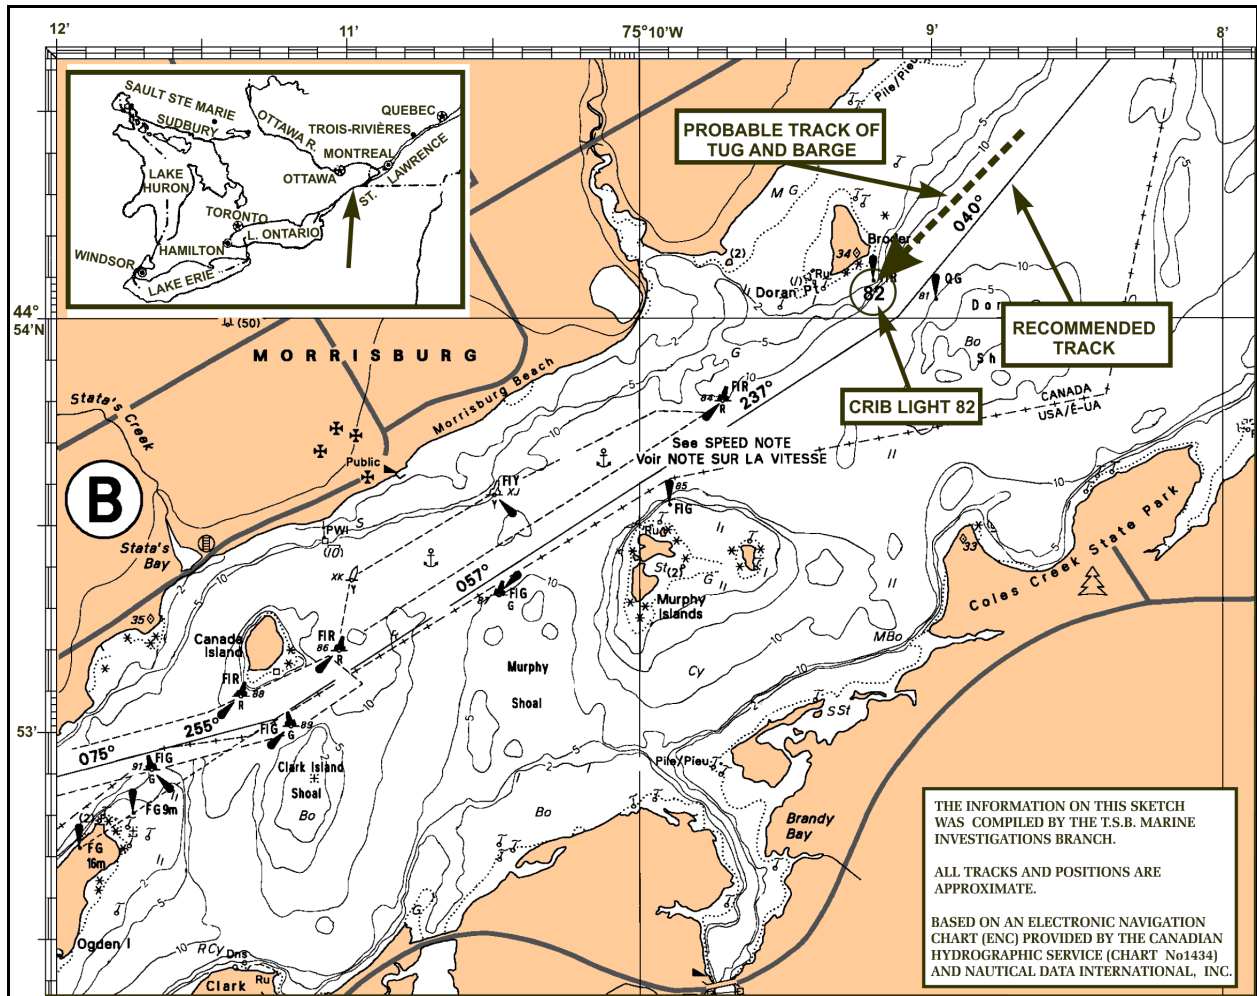
# Appendix A – Sketch of the Occurrence Area

At approximately 2230, the captain was in his cabin and the tow was approaching Broder Island when two successive crashing sounds were heard as the tug jolted abruptly to port. The tug-barge unit had knocked down crib light 82 and continued to sail over the submerged navigation aid. (See Appendix A – Sketch of the Occurrence Area.)
